Test Report

No. CANEC1909434211

The following sample(s) was/were submitted and identified on behalf of the clients as : METALLIZEDFILM
CAPACITOR(BOX)

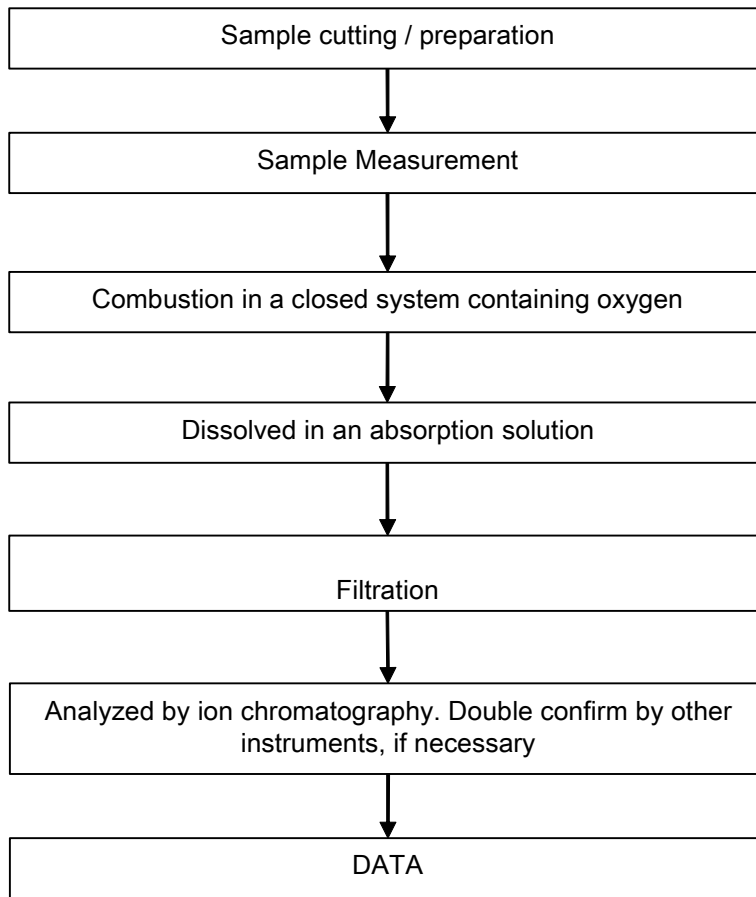
Halogen Testing Flow Chart

Test Method : With reference to EN 14582:2016, analysis was performed by IC.

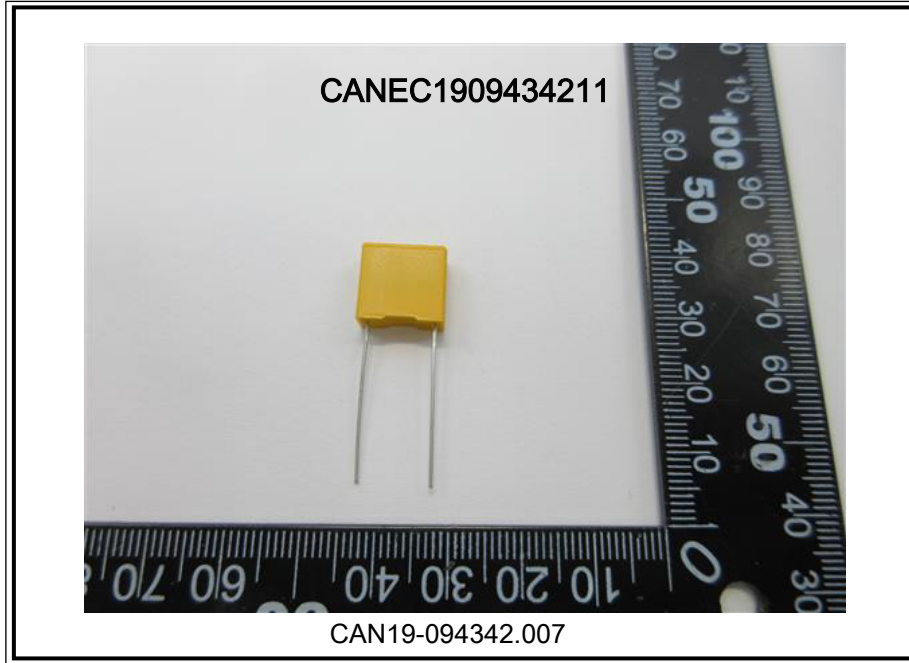
Sample photo:

Specimen No.	SGS Sample ID	Description
SN1	CAN19-094342.007	METALLIZEDFILM CAPACITOR(BOX)(mixed)
